TEM observations of wear mechanisms of TiAlCrN and TiAlN/CrN coatings grown by combined steered-arc/unbalanced magnetron deposition

LUO, Quanshun, RAINFORTH, W.M. and MÜNZ, W.D. (1999). TEM observations of wear mechanisms of TiAlCrN and TiAlN/CrN coatings grown by combined steered-arc/unbalanced magnetron deposition. *Wear*, 225-22 (1), 74-82.

TEM observations of wear mechanisms of TiAlCrN and TiAl_{Nr}CrN coatings grown by combined steered-arc/unbalanced magnetron deposition

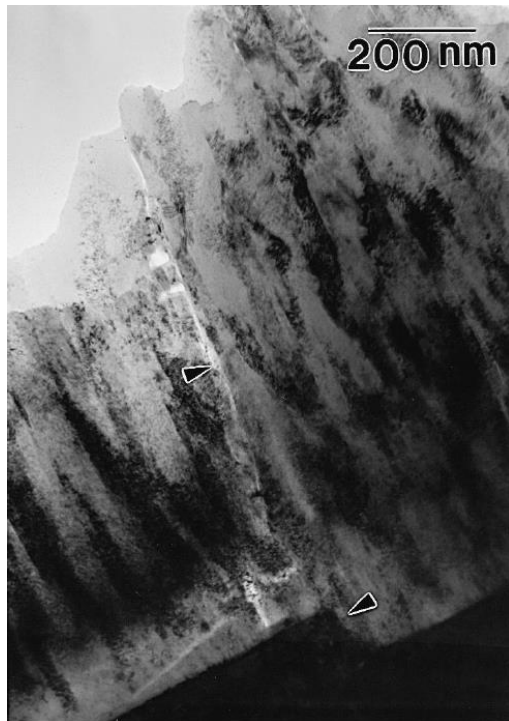
Fig. 9. Bright field TEM micrograph from a longitudinal cross-section sample of the worn TiAlCrN monolayer showing the displacement of the substrate arrowed. and the cracking in the coating arrowed., similar to that seen in the multilayer coating in Fig. 5.

Fig. 9 gives micrographs from the wear scar of the TiAlCrN in regime 2., i.e., where the coating contained macroscopic cracking. Extensive plastic deformation had occurred in the BM2 substrate. The coating had fractured extensively, with a regular displacement of both coating and substrate, giving a 'saw-tooth' type appearance, similar to that seen in Fig. 2c. Again,

fracture of the coating occurred predominantly in two orientations, along columnar grain boundaries and

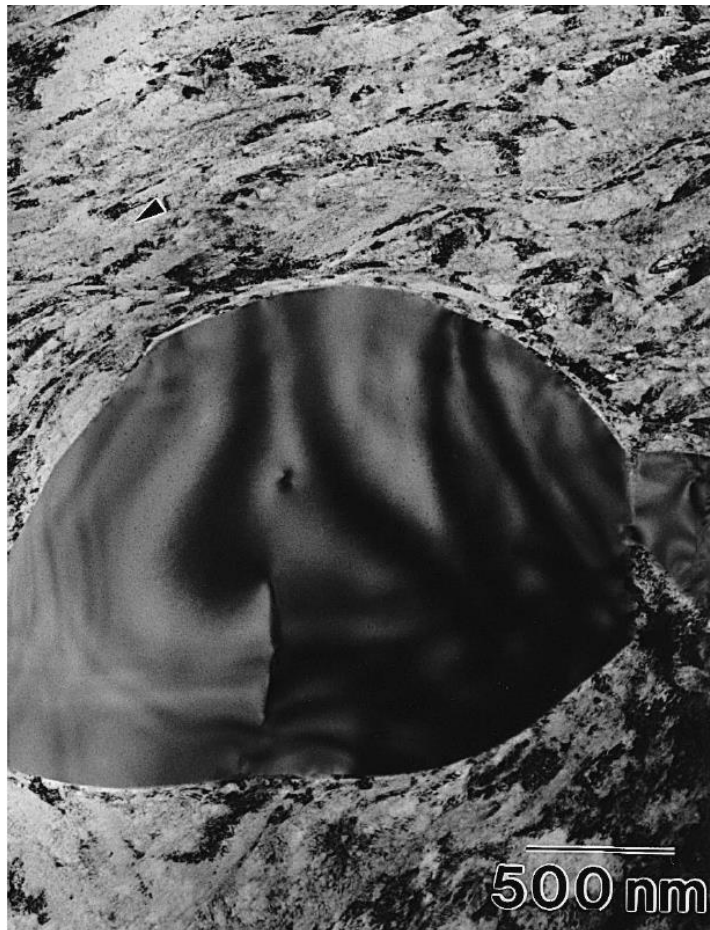
Fig. 11. Bright field TEM micrograph from a longitudinal cross-section of the worn surface of the uncoated BM2 steel. Extensive plastic deformation is present, which has flowed around an MC carbide worn surface at the upper end of the micrograph. The arrow indicates the direction of sliding.

within $\sim 20^\circ$ of parallel to the coating surface. Cracking was mainly contained within the coating, but occasionally propagated into the substrate Fig. 10. In contrast to the absence of plastic deformation in the multilayer coating and the limited plastic deformation in the TiAlCrYN and TiAlCrN coatings, extensive plastic deformation was found at the surface of the uncoated BM2

steel Fig. 11. The martensitic structure present at the start of the test had been transformed into a predominantly α -Fe structure, with associated deformation texture a weak $\{100\}<110>$ texture.

Subgrain size decreased as the worn surface was approached, with a minimum thickness of ~ 20 nm observed Fig. 12. Fig. 11 also shows the extensive plastic flow of the matrix around the

MC carbide where M denotes W, Mo, V, Cr. and the manner in which subgrain size reduces close to the MC/matrix interface.

the hard martensitic structure present before testing to a heavily deformed α -Fe structure. The same conditions induced minor deformation in the TiAlCrYN and TiAlCrN coatings and no deformation in the TiAlN/CrN multilayer. There has been considerable debate as to the origin of the very high hardness values of the 'superlattice' multilayer coatings [32–37]. While the precise origin is controversial many theories have been proposed, for example, elastic modulus effects [32], alternating stress fields [33], the difference in dislocation line energy between the layers [34–37] and coherency strains [37], Hall–Petch effect [38], it is clear that dislocation flow is severely retarded by the multilayer structure compared with the monolithic counterparts. The current TEM observations are in accord with this view. The layer structure provides a useful microstructural marker that would allow the presence of plastic deformation at the surface to be readily detected. Even in the outer few nm, the superlattice structure was retained and showed no obvious distortion. It should be emphasized that dislocation flow in a hard tool steel such as the BM2 used here requires high contact stresses and the presence of such extensive plastic deformation Figs. 11 and 12 demonstrates the severity of the contact conditions.
